CAFO FACILITY INSPECTION REPORT

<u>8335678001</u> WDID NUMBER	<u>Andy Dyt</u> OWNER NAME	<u>Dyt Heifers</u> FACILITY NAME
<u>CAG018001</u> NPDES NUMBER	<u>Ex. 6 Personal Privacy (PP)</u>	
<u>R8-2007-0001</u> RWQCB ORDER NO.	<u>Corona, CA 92880</u> OWNER CITY AND STATE	<u>Corona, CA 92880</u> FACILITY CITY AND STATE
<u>04/10/2013</u> SCHEDULED INSPECTION DATE	<u>Andy Dyt</u> OWNER CONTACT	<u>Andy Dyt</u> FACILITY CONTACT
<u>04/10/2013</u> ACTUAL INSPECTION DATE	<u>Ex. 6 Personal Privacy (PP)</u>	
<u>Santa Ana River</u> RECEIVING WATER	<u>Ex. 6 Personal Privacy (PP)</u>	
	<u>Ex. 6 Personal Privacy (PP)</u>

REPORT PREPARED BY: Anthony D'Angelo (PG Environmental, LLC) ON 04/22/2013

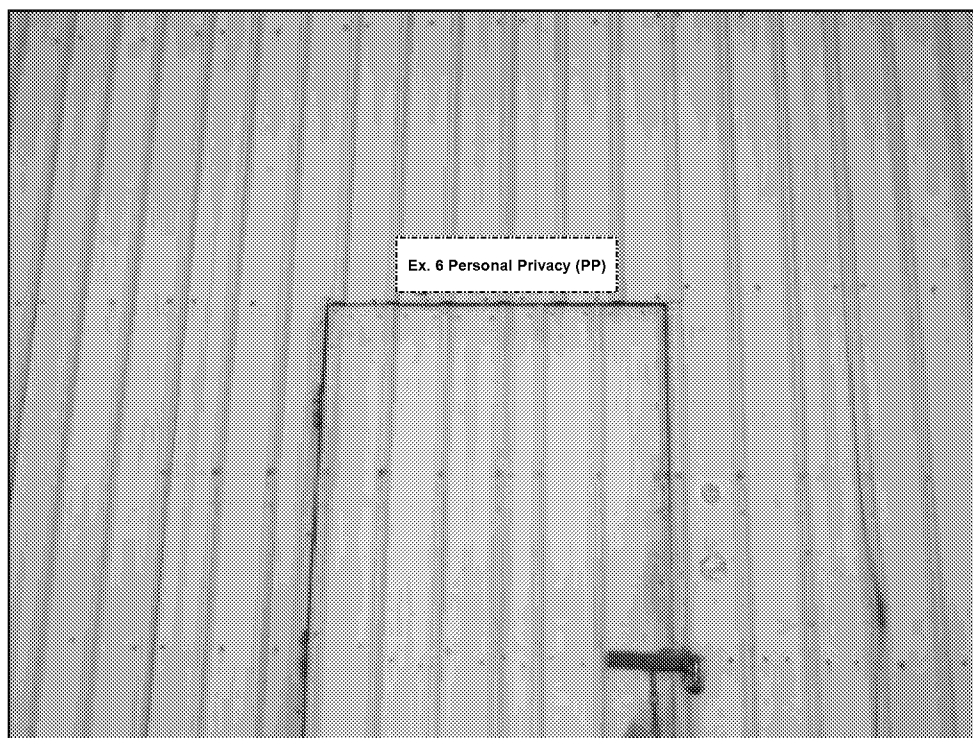
Photograph 1. Facility milking barn address. Dyt Heifers and J & D Star Dairy No. 2 both operate at the same Facility, shown in Photograph 2.

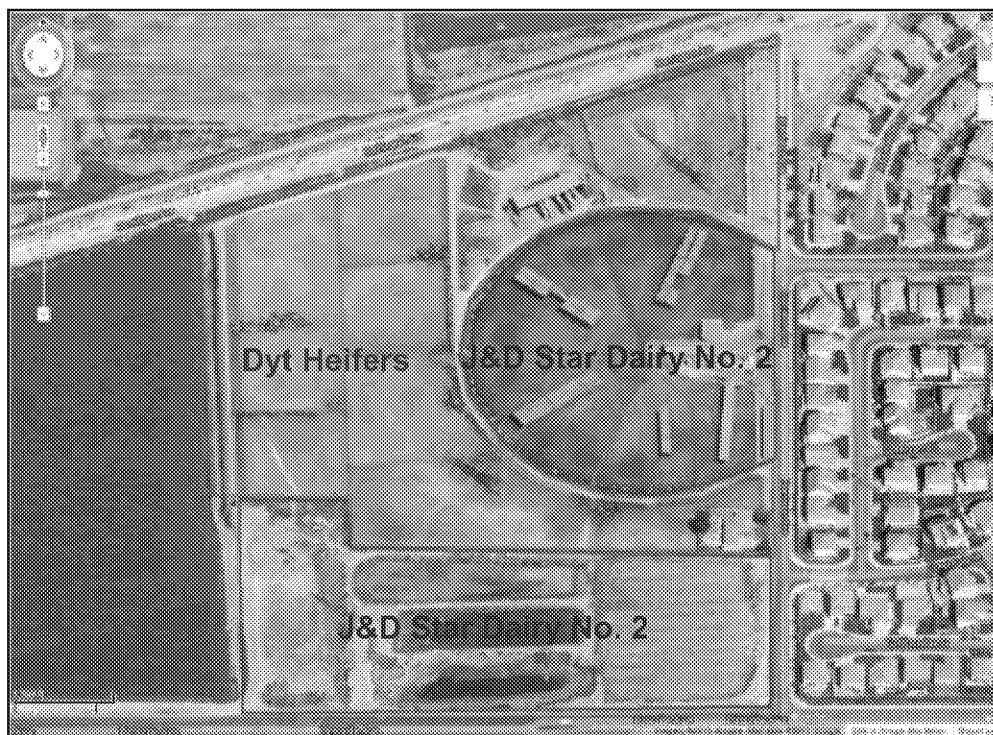
Photograph 2. GoogleMaps satellite image of the Facility identifying the two separate CAFOs operating at the Facility, Dyt Heifers and J & D Star Dairy No. 2.
